A Smart Inspection Report

Client: Abby B. Normall
Address: 9610 Sample; St. Louis, MO 63123

Date: August 9th, 2009

Report Prepared by: Jeremy Paschedag

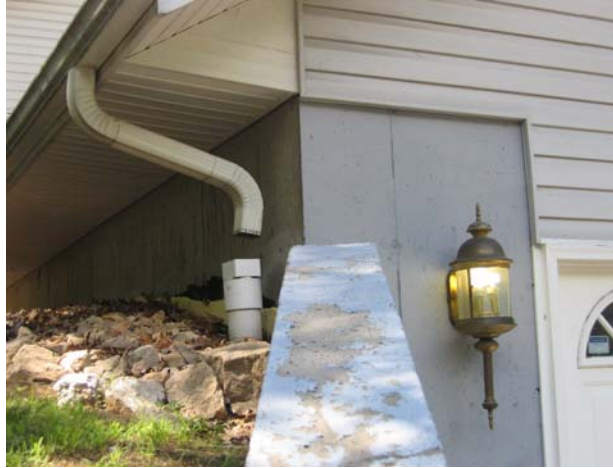
Action Needed: Down spout not connected to drainage pipe. Without this connection the runoff water might seep down the foundation resulting in penetration into the garage.

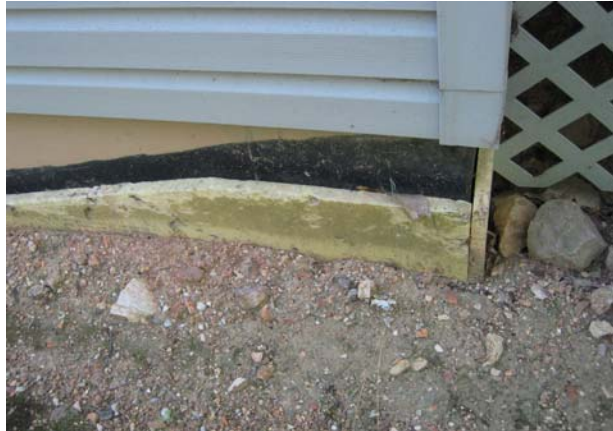
Action Needed: The foam insulation between the ground and the foundation needs to be sealed to help prevent water from seeping between the insulation and the foundation (as this could result in water penetrating the foundation walls and into the home).

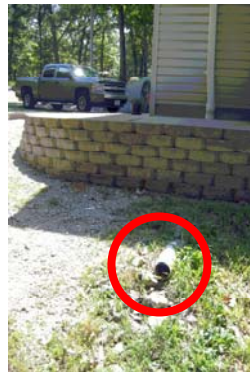
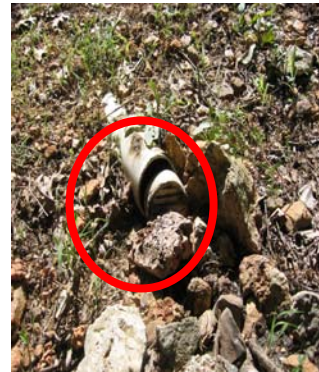
Recommendation: The gutter drainage lines are either missing a screen or the screen is not attached. The screens prevent rodents from nesting or expiring in the lines, thus causing possible backflows and/or unpleasant odors.

Recommendation: The drain cover is not fastened to anything. As a result the cover can shift leaving an open hole.

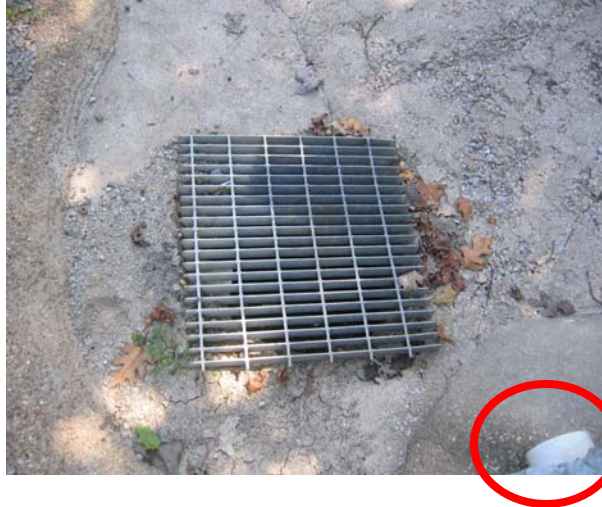
The gutter drainage line is missing a screen. The screen prevents rodents from nesting or expiring in the lines, thus causing possible backflows and/or unpleasant odors.

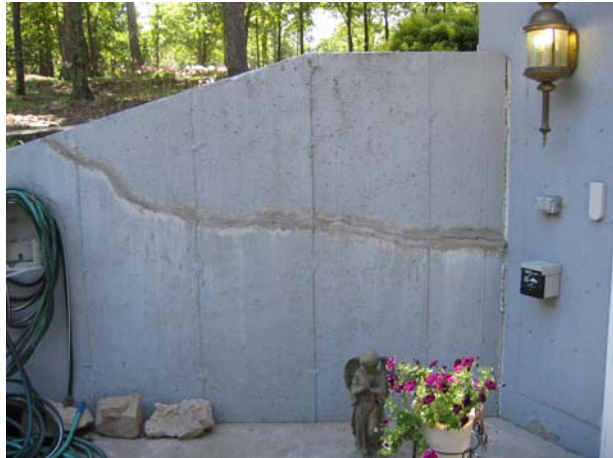
Recommendation: The retaining wall has a crack that spans the width of the wall. And where the retaining wall butts up to the garage wall, there is separation. If these issues continue to progress, the wall (or part of it) might collapse.

On the other side of this retaining wall the ground level and the top of the wall is only about a foot in difference. This wall should have a railing installed to prevent someone from accidentally falling over it, resulting in accidental personal injury.

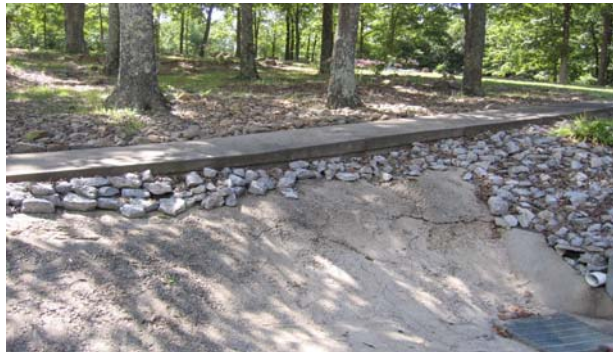
Recommendation: On the walkway between the walkway and the garage, there is a steep drop-off that should have a railing to prevent accidental personal injury.

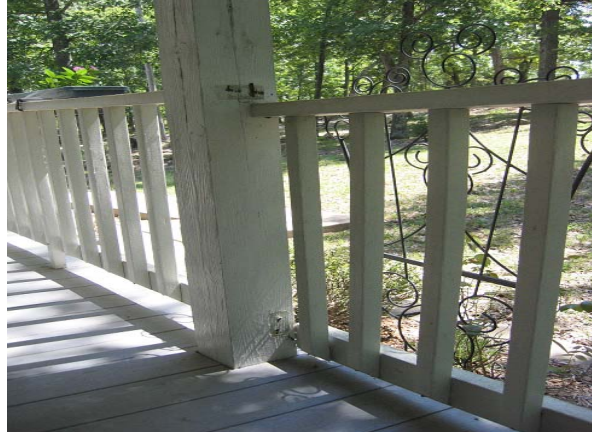
Action Needed: One side of one section of the railing is no longer attached to the post. In the current condition, this could cause accidental injury.

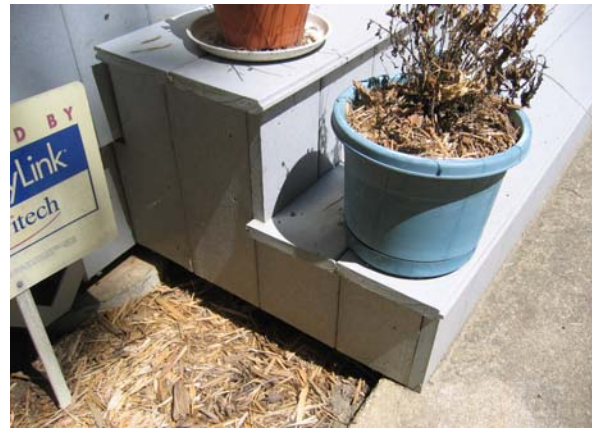
Action Needed: The steps to the front porch from the walkway are not level and are separating from the porch. As a result in visitors may slip and become injured. Unable to determine if this is the result of poor craftsmanship or settling.

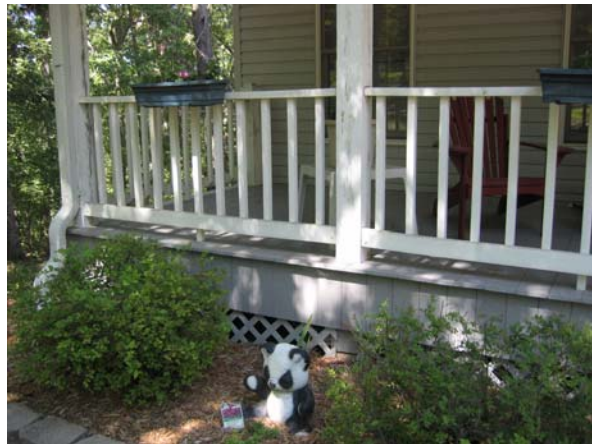
Recommendation: The spindles on the front porch railing are spaced more than 4 inches apart. Building standards say that they should be spaced not more than 4 inches apart.

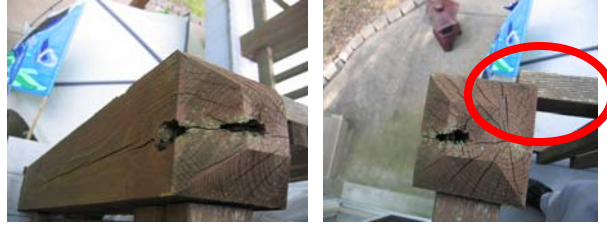
Recommendation: One of the posts is rotting. If this continues, the post may not be able to maintain a strong connection to the railing resulting in serious personal injury.

In the second picture, the top railing is missing from the railing in the cut out on the left side.

All of the railing on the deck needs to be re-stained. Typically this should be done every 2-3 years.

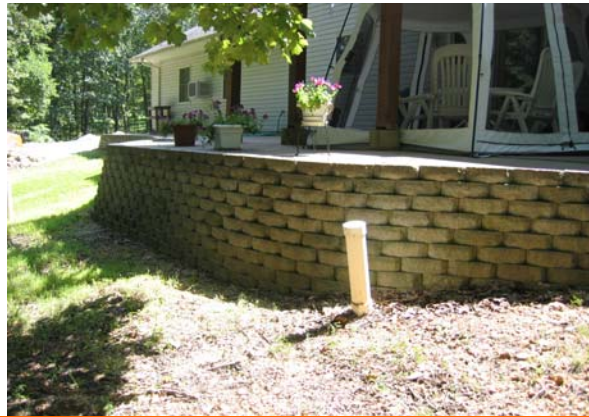
Recommendation: The patio should have a railing installed to prevent someone from accidentally falling off the patio, resulting in accidental injury. Railing should be installed when the differences in height are more than 3 feet.

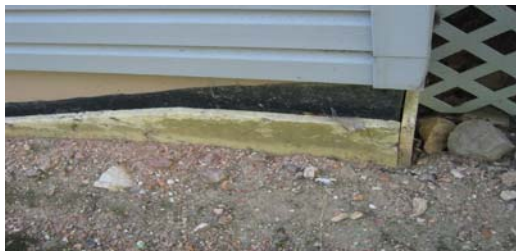
Action Needed: The foam insulation between the ground and the foundation needs to be sealed to help prevent water from seeping between the insulation and the foundation (as this could result in water penetrating the foundation walls and into the home).

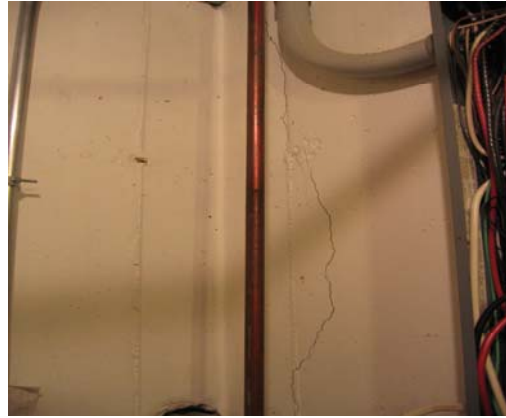
1a

Action Needed: On the wall with the electrical panel and the washing machine and dryer there are two sets of cracks from the top of the foundation wall to the floor. And picture 1b shows that the crack has continued to the floor. These cracks are parallel to each other about 11 feet apart. Please seek the advice of a structural engineer.

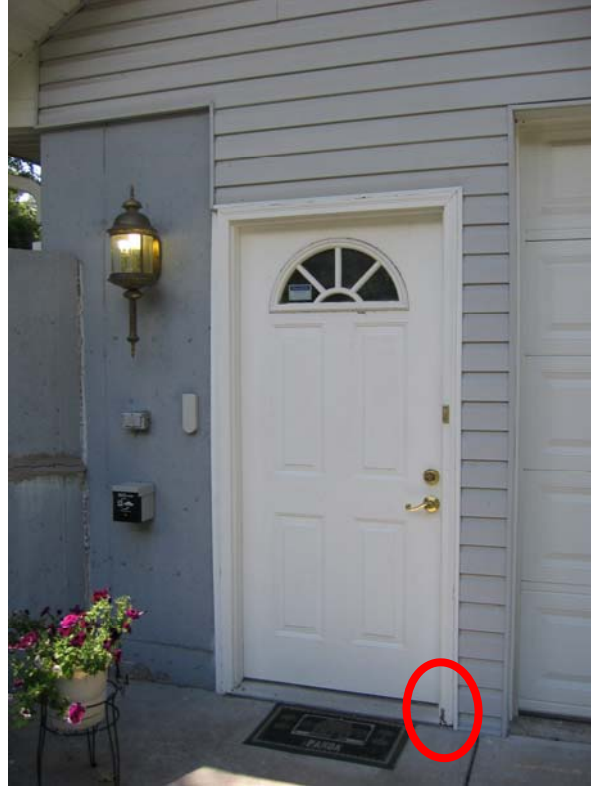
Action Needed: The lower, right side door jamb has started to rot. The paint has started peeling off the trim. These need to be addressed to eliminate further deterioration.

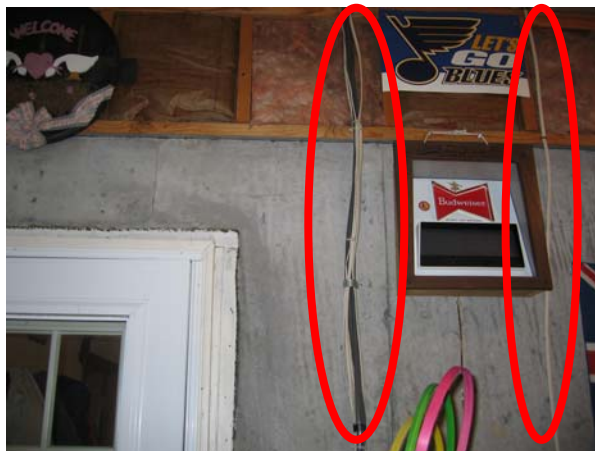
Action Needed: The electrical wires leading to the outlets (2) located near the door leading into the house should be enclosed in conduit.

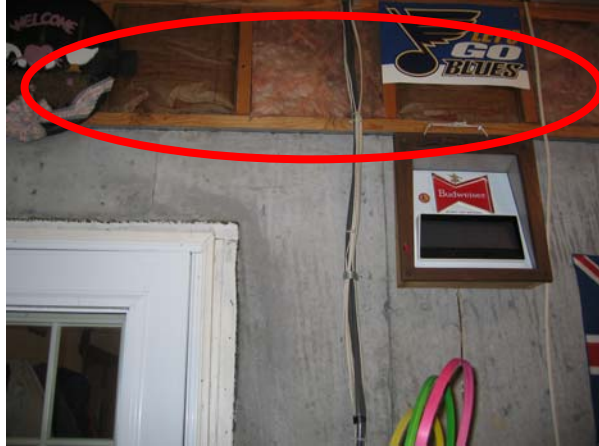
Suggestion: There is exposed insulation that should have a covering.

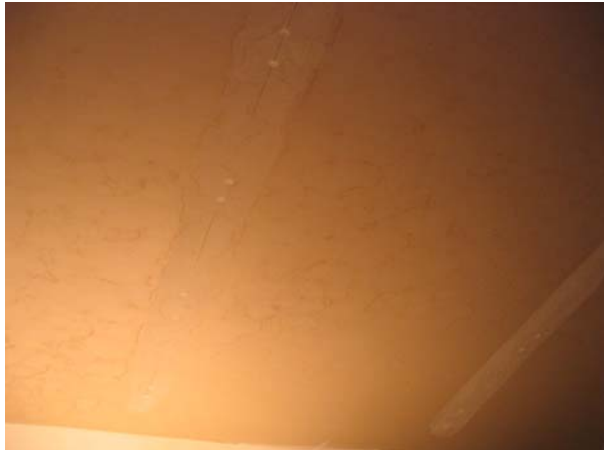
Recommendation: The ceiling has unapproved, bare (neither painted nor primed) drywall. Bathrooms should be constructed of proper materials suitable for areas that contain moisture.

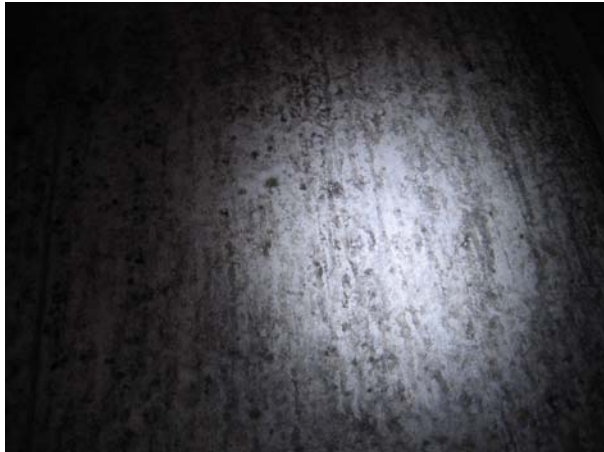
Action Needed: The concrete wall behind the well water pump and the shower is covered with what looks like mildew (or possibly mold). I would contact someone from either the Center for Disease Control (CDC) or the Environmental Protection Agency (EPA) as soon as possible for further consultation.

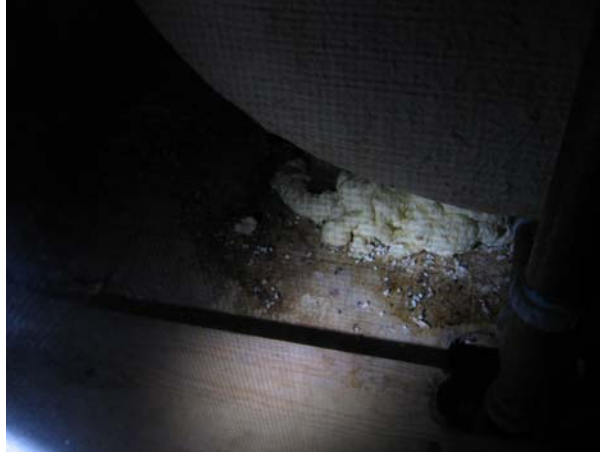
Action Needed: The tub drain appears to have a leak. This needs to be fixed to eliminate water from causing rot to the wood sub floor underneath the tub.

It appears that a rodent has been in this area. This is based on the droppings found. I did not notice any other signs of rodents.

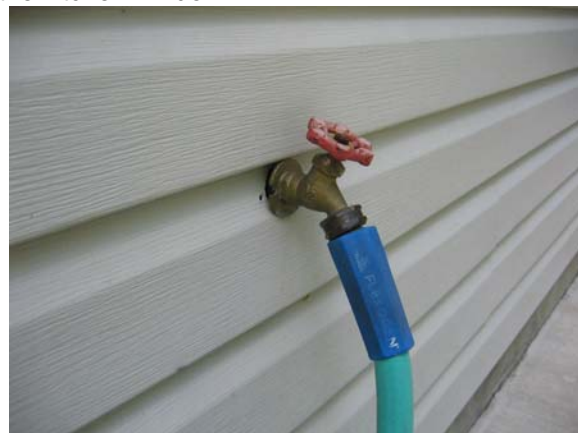
Action Needed: The was not installed properly. There should not be a opening between the spigot and the siding. Water could penetrate at this area causing damage.

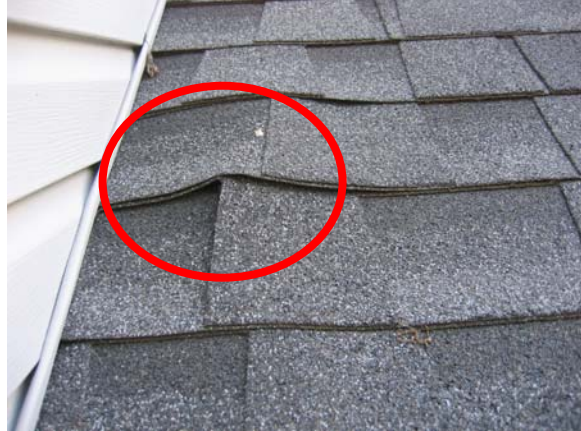
Recommendation: On the front of the garage roof where it is adjacent to the side of the house there is a bulge. This could result in leakage and damage.

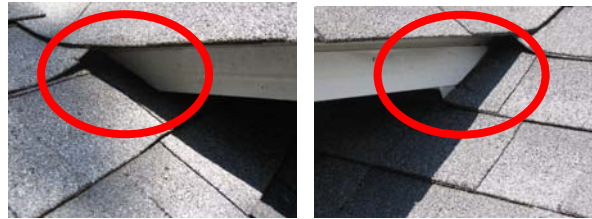
Action Needed: The dormer on the left side (when facing the house) is missing flashing (picture on the left). The picture on the right shows flashing. There are four areas where the roof of the dormer meets the roof. It is only the left side of the left dormer that does not have the flashing. The good news is that currently it does not appear water has penetrated the roof (by observations in the attic). Without proper flashing, water may penetrate the roof and into the attic causing damage.

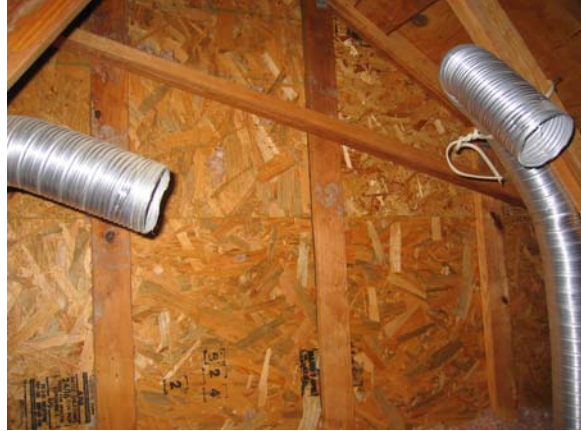
Action Needed: The ventilation from the bathrooms vent to the attic instead of through the roof. Dark, warm, moist places are not a good combination as they tend to promote mold/mildew.

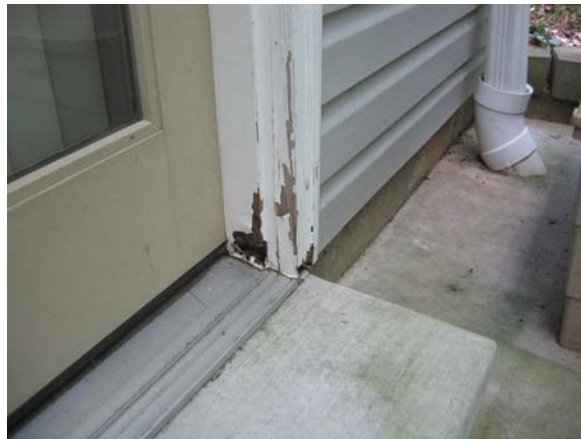
Action Needed: The exterior, right side, door jamb has begun to rot. The paint on the trim is peeling off. These need to be fixed to prevent further damage.

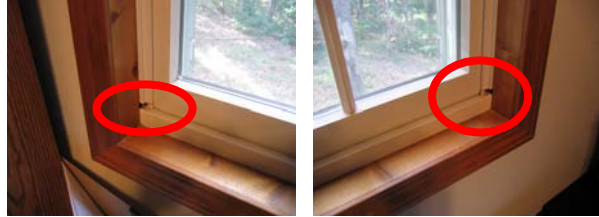
Suggestion: The window jamb has about ½ inch gap in both lower corners. Fixing these so the jambs come all the way down to the sills might help in air loss.

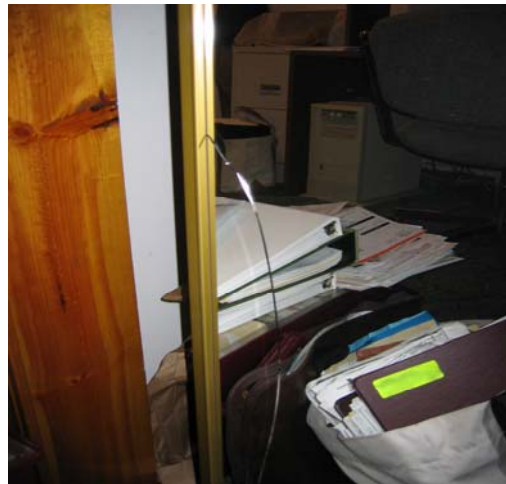
Suggestion: The left side sliding mirror door has a crack that is about two feet in length. I would suggest replacing the door to eliminate any slivers of glass that might accumulate on the carpet near the door from normal use.

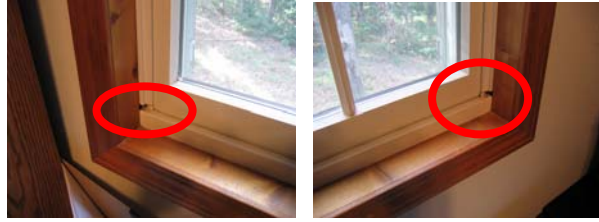
Suggestion: The window jamb has about ½ inch gap in both lower corners. Fixing these so the jambs come all the way down to the sills might help in air loss.

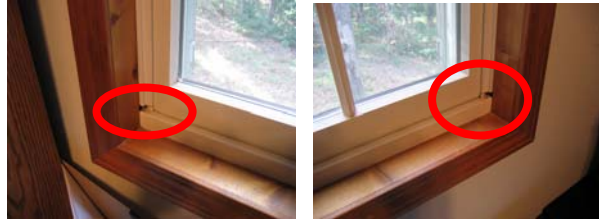
Suggestion: The window jamb has about ½ inch gap in both lower corners. Fixing these so the jambs come all the way down to the sills might help in air loss.

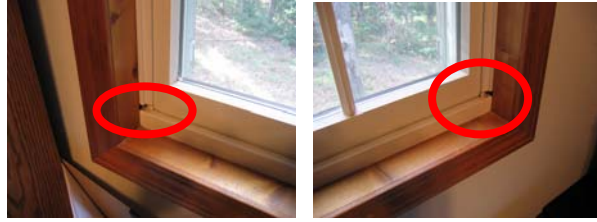
Suggestion: The window jamb has about ½ inch gap in both lower corners. Fixing these so the jambs come all the way down to the sills might help in air loss.

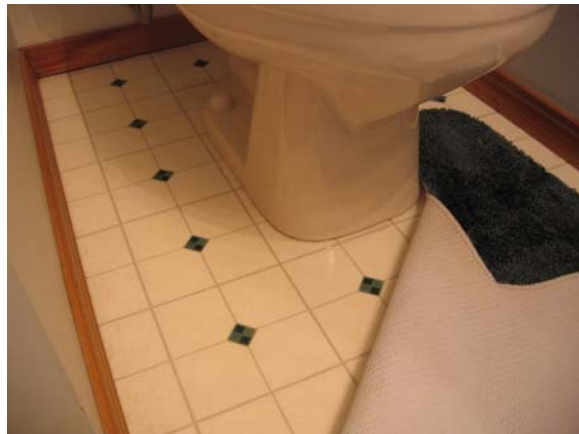
Suggestion: I suggest that you caulk around the base of the toilet where it rests on the floor. This will help prevent moisture showers/baths and mopping from getting underneath the toilet and causing mold and/or rot.

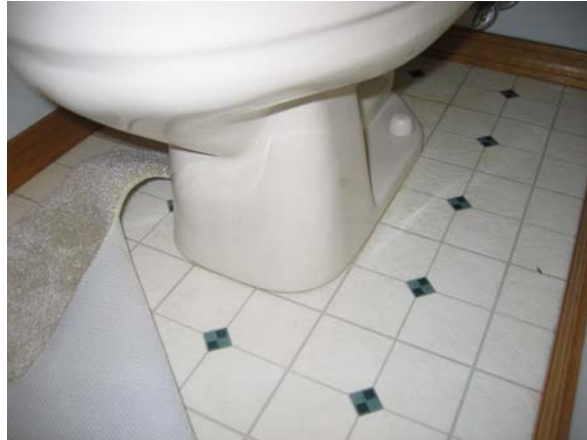
Suggestion: I suggest that you caulk around the base of the toilet where it rests on the floor. This will help prevent moisture showers/baths and mopping from getting underneath the toilet and causing mold and/or rot.

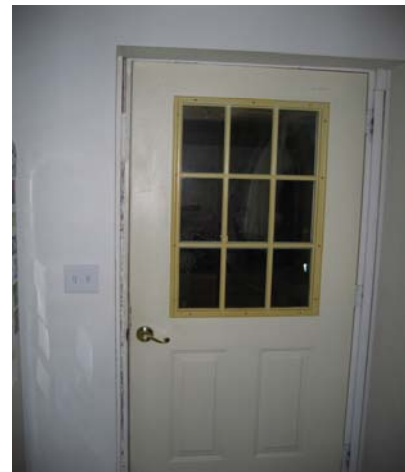
Recommendation: The door from the garage to the house on the kitchen side of the door, the trim is missing.

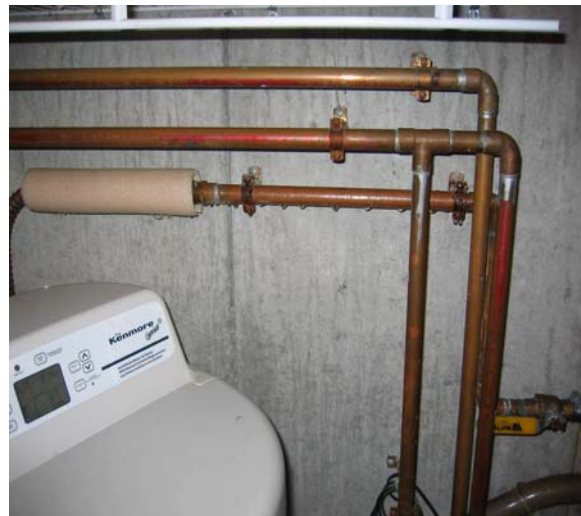
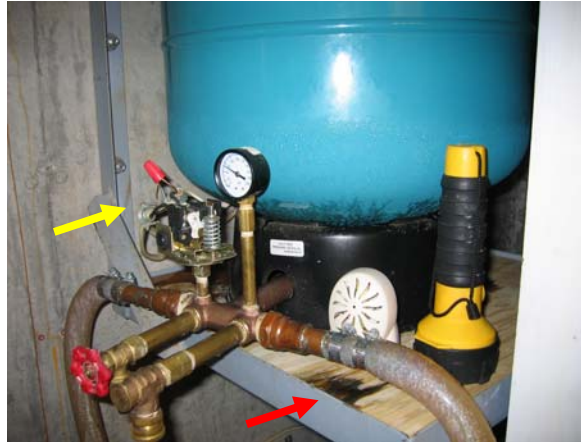
The lower picture also shows condensation on the tank and tubing. As you can also see, the plywood under the well water pump, has begun rotting (red arrow). In addition, the control device is missing a cover, thus exposing the wires (yellow arrow). This can cause harm to someone who might

touch them.
