A Smart Inspection Report

Client: Abby B. Normall
Address: 9610 Sample; St. Louis, MO 63123

Date: August 9th, 2009

Report Prepared by: Jeremy Paschedag

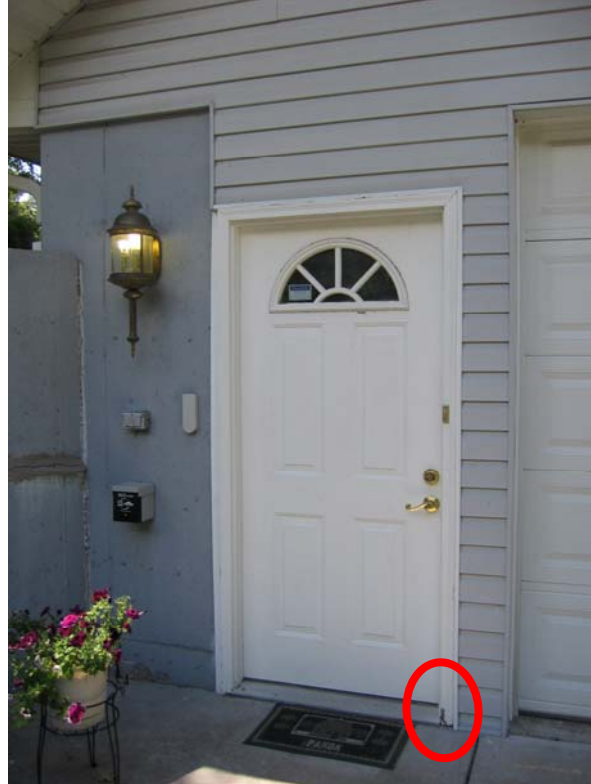
Action Needed: The lower, right side door jamb has started to rot. The paint has started peeling off the trim. These need to be addressed to eliminate further deterioration.

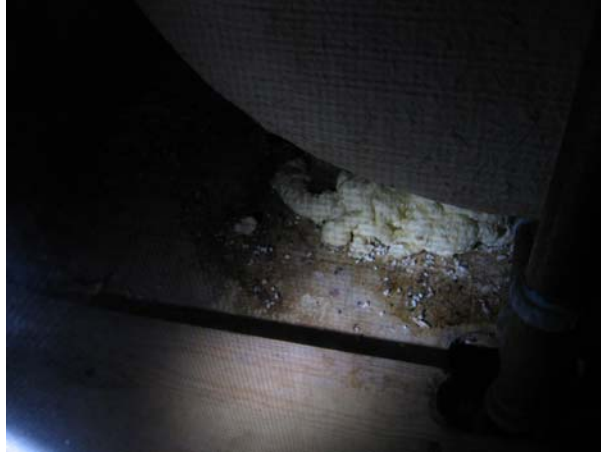
Action Needed: The tub drain appears to have a leak. This needs to be fixed to eliminate water from causing rot to the wood sub floor underneath the tub.

It appears that a rodent has been in this area. This is based on the droppings found. I did not notice any other signs of rodents.

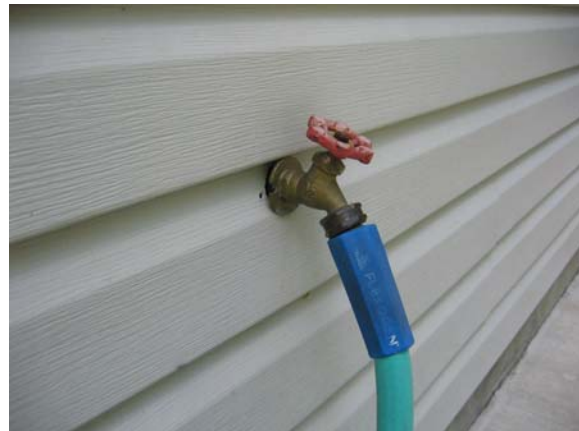
Action Needed: The was not installed properly. There should not be a opening between the spigot and the siding. Water could penetrate at this area causing damage.

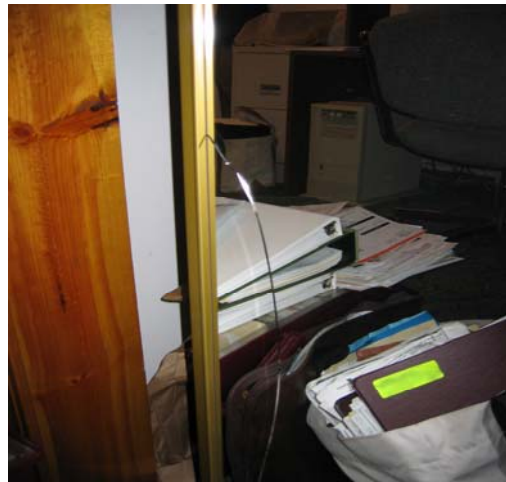
Suggestion: The left side sliding mirror door has a crack that is about two feet in length. I would suggest replacing the door to eliminate any slivers of glass that might accumulate on the carpet near the door from normal use.

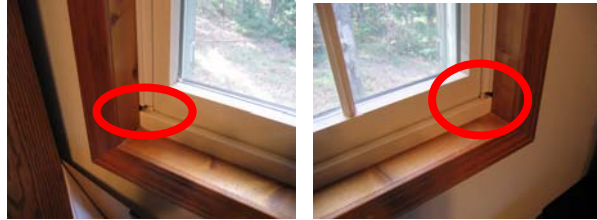
Suggestion: The window jamb has about ½ inch gap in both lower corners. Fixing these so the jambs come all the way down to the sills might help in air loss.
